THESIS

MICROSCOPIC INVESTIGATION OF INTERFACE
CORROSION OF STEEL-ALUMINUM EXPLOSIVELY
BONDED MATERIAL EXPOSED TO
PERIODIC SEA WATER SPRAY

September 1976

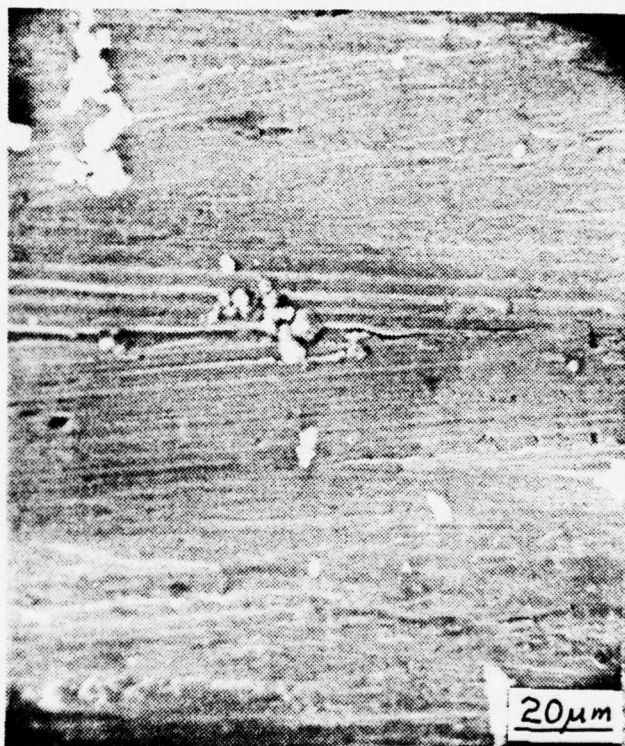
Figure 42. 700x SEM picture of beginning of rusting at surface deformity on steel after two-hour exposure.

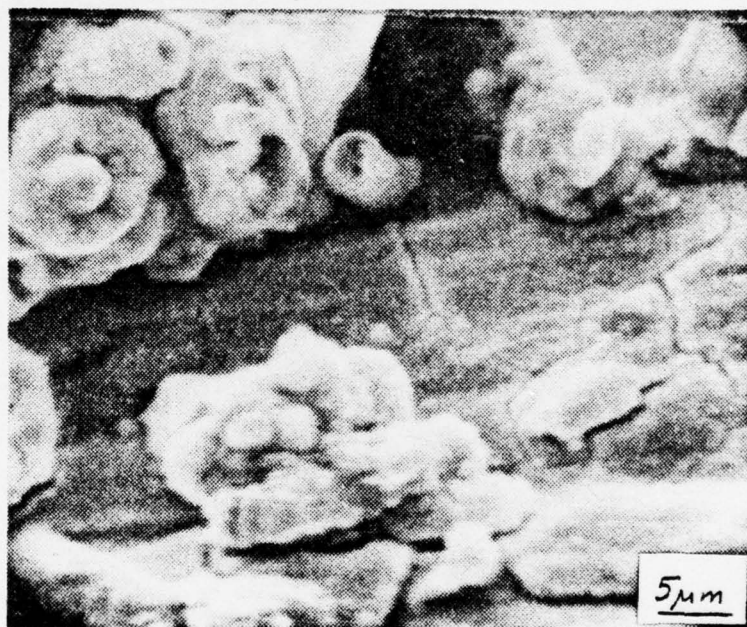
Figure 55. 2050x SEM picture showing iron oxide growth through film of alumina on steel after 12-hour exposure.

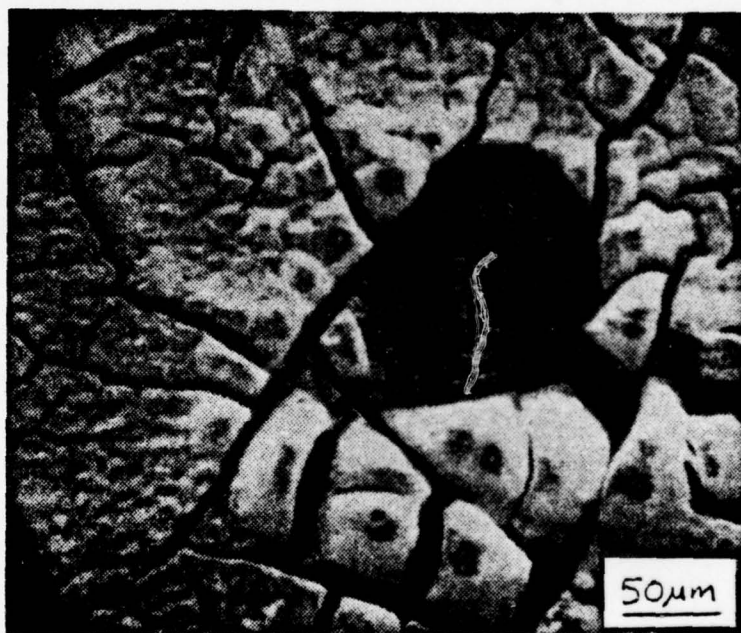
Figure 63. 280x SEM picture of alumina layer beneath second corrosion product film on five-week exposure sample (Steel surface).
